Champlain Bridge, Montreal, Canada

Integrated safety for structures

Damage evolution Monitoring on an essential bridge

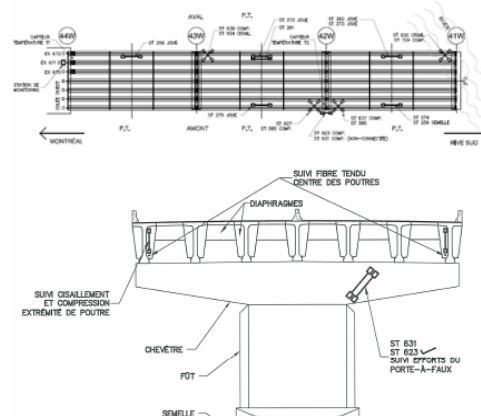
Instrumentation sketch with joist detail

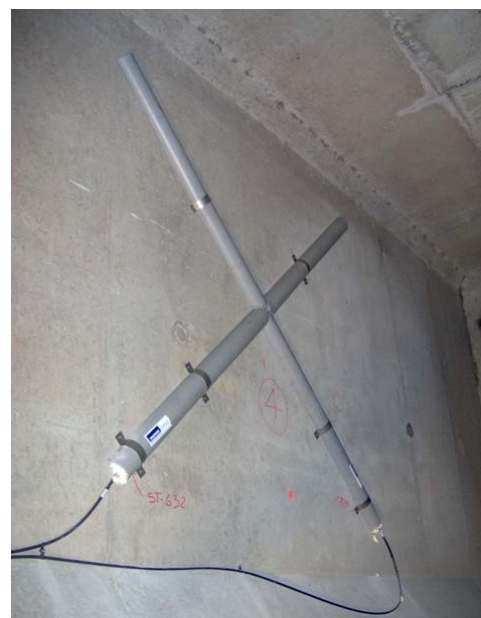
Orthogonal Optical Strands to measure shear stress

- 18 Optical Strands
- 3 optical extensometers as WIMS sensors
- 1 temperature sensor
- 1 monitoring station

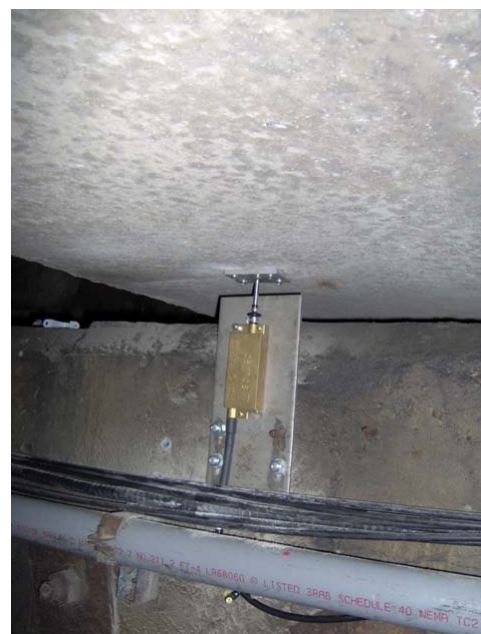
Optical extensometer as a WIMS sensor
