Köhlbrand Bridge, Hamburg, Germany

Integrated safety for structures

Bridge stability monitoring

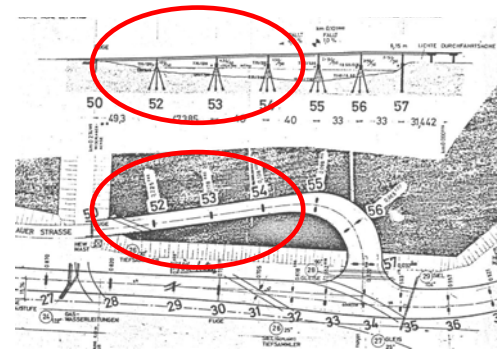
Instrumentation location

- 8 Optical Strands
- 2 flood detectors
- 8 temperature sensors
- 1 monitoring station

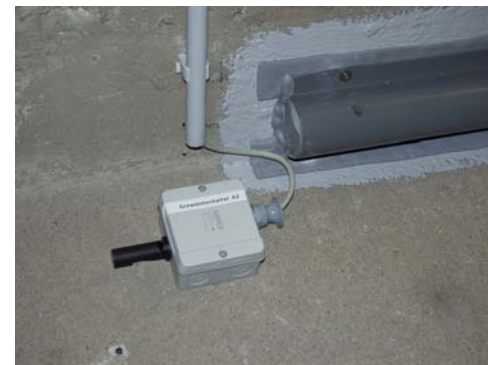
Flood detector near an Optical Strand

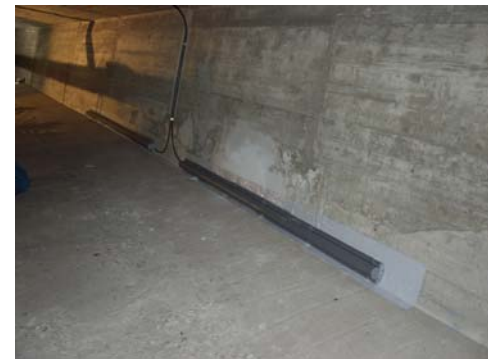
Dual 2-meter Optical Strands inside the bridge deck

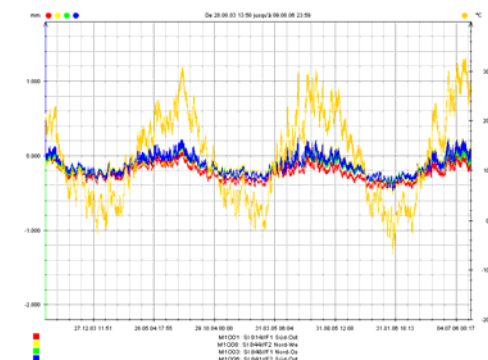
Static deformations over 3 years

Initial results show the bridge to be functioning in a safe mode.
