# Manhattan Bridge, New York City, USA

## Monitoring a Bridge during Stiffening Work

Manhattan Bridge  
New York City, USA

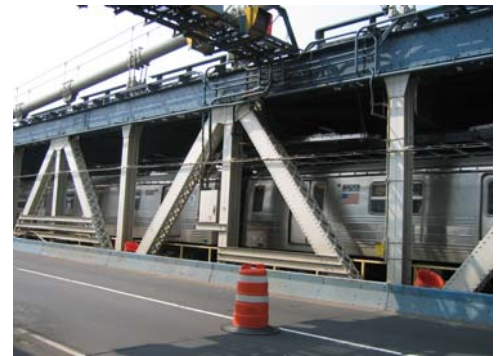
Train passing
