Safety monitoring during construction works

Schmallwasser Dam
Rock fill dam in Germany for the supply with drinking water in Thuringia

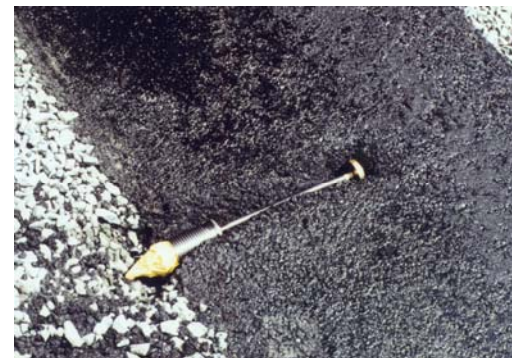
Concrete/asphalt junction of the extensometer

14 optical extensometers have been installed for the 3 dimensions monitoring. The sensors have been embedded inside the asphalt.

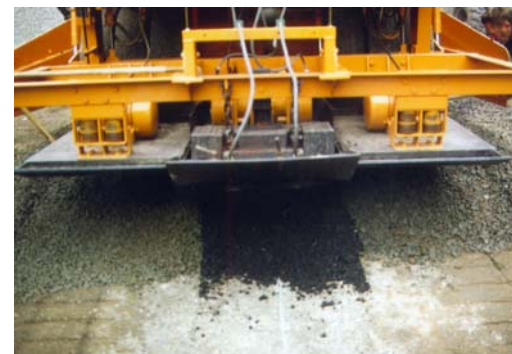
Positioning of an asphalt seal

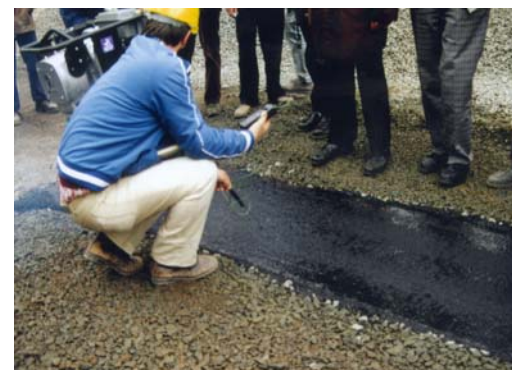
Checking the quality of the asphalt
