Lohsa Railway, Germany

Sinkhole monitoring

Railway between Horka-Falkenberg,
km 60,0 – km 60,8 (Lohsa Train Station)
Double line Railway, built in the 1950's

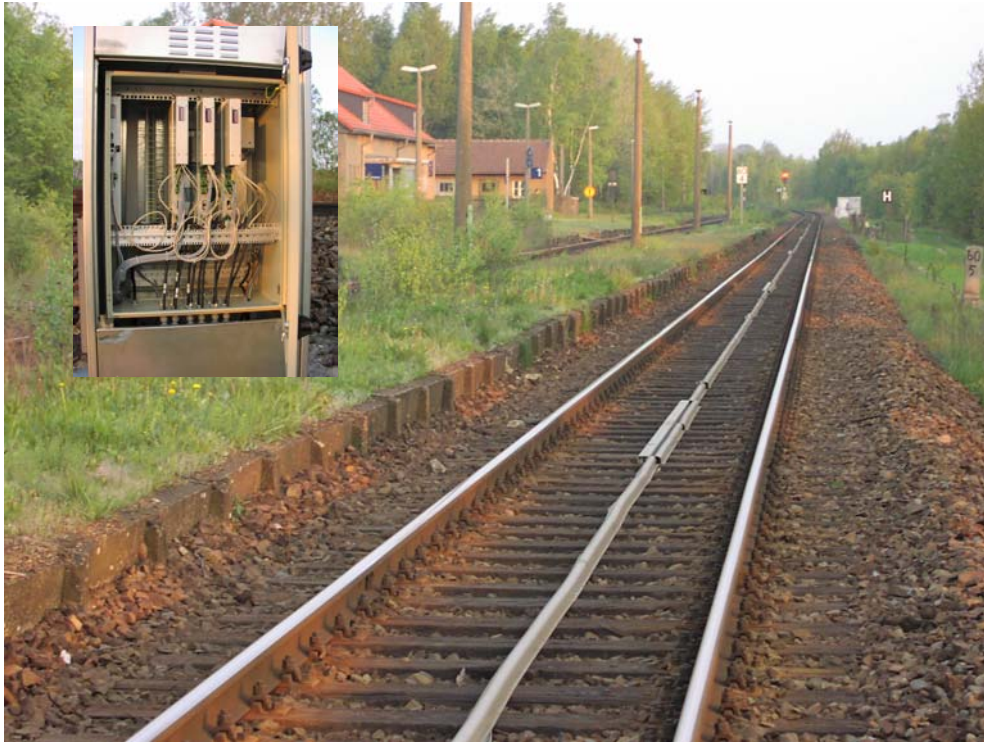
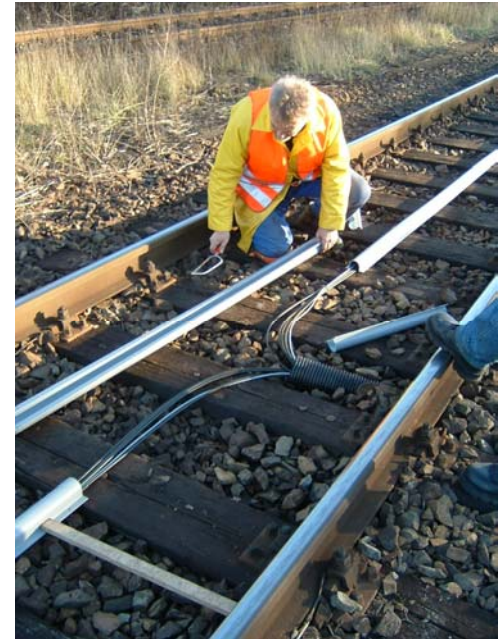
Optical Strands installation on the track

- 20 x 10-m Optical Strands
- 1 temperature sensor
- 1 monitoring station

The equipment can monitor up to 800
meters of rail tracks.

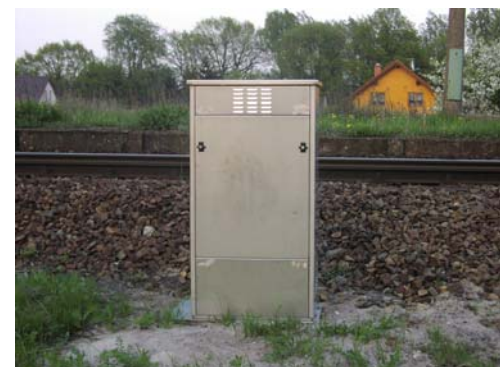
Monitoring station specifically designed for
outdoor operations.

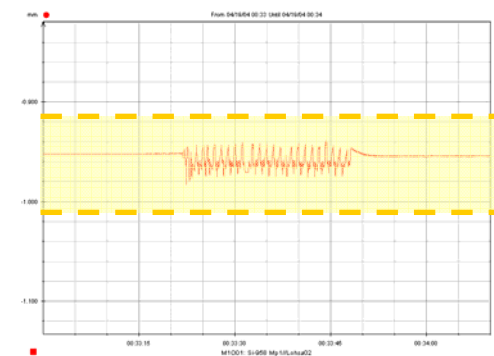
Train passing through the different Optical
Strands over the tracks

An occurrence of sinkhole will modify
considerably the dynamic deformation of a
train passing.
