Olten Retaining Wall, Switzerland

Safety availability of a retaining cantilevered wall

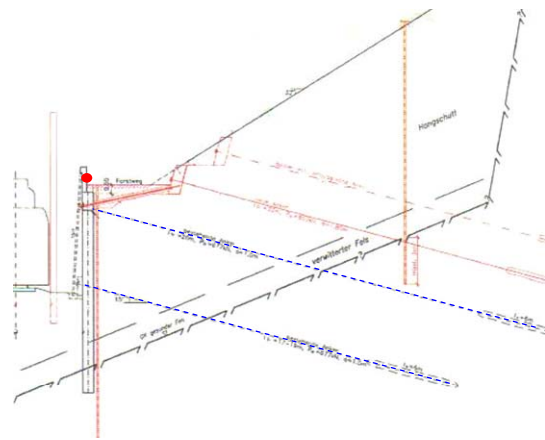
Section of the retaining wall. Optical Strands generating line is localized with the red spot. Tie positions are in blue.

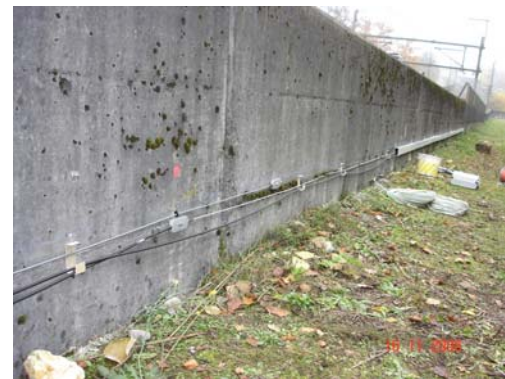
Installation of the Optical Strands, along the wall.

- 1 monitoring station
- 12 x 10 m long Optical Strands
- 6 inclinometers
- 6 temperature sensors

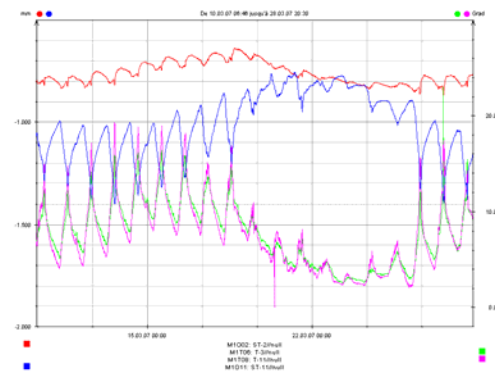
Reaction of Optical Strands (elongation in mm, ST1 in red and ST11 in blue,) to temperature variation (in pink and green)

During a calibration period, the normal behaviour of the wall and the influences of external parameters are defined. A characteristic elongation of a part of the superior wall would prove a failure in the anchorage.
