# Conveyor Bridge, Vatenfall, Welzow, Germany

## Availability of a bridge in a mining environment

Metallic feeding bridge F60 in an open-sky coal mine, built in 1972.

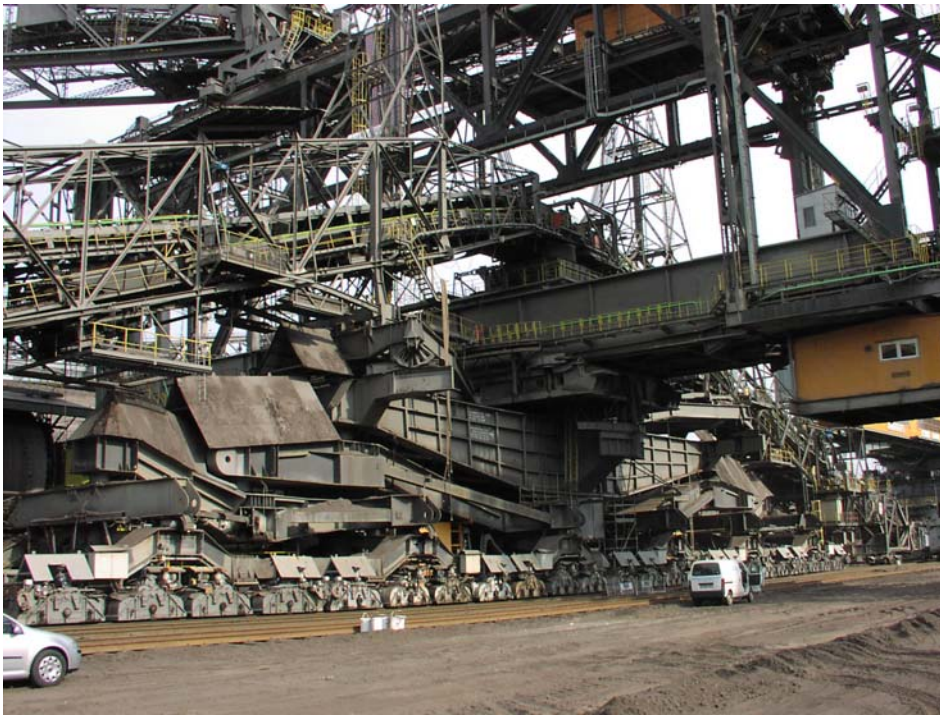
Location of the monitoring equipment

- 8 Optical Strands (4x2-m and 4x1,8m)
- 1 temperature sensor
- 1 monitoring station

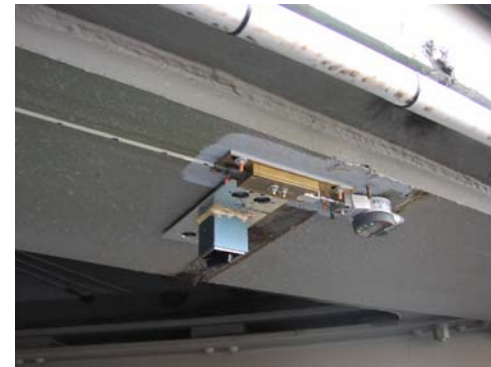
Optical Strand splice box equipped with a micrometer

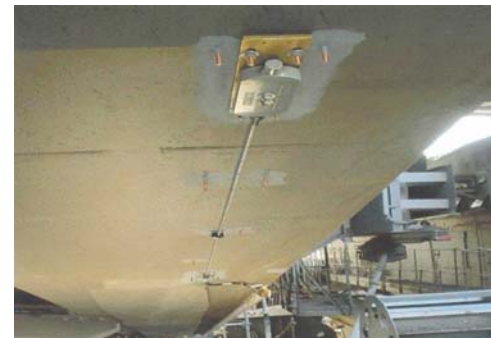
Optical Strand without protection

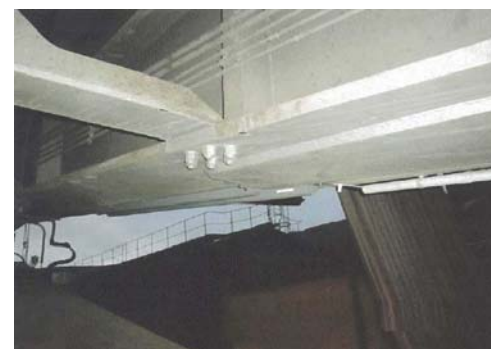
Optical Strand with protection
