Subway tunnel, 119 Fulton Street, New York City, USA

Integrated safety for structures

Monitoring of a tunnel under adjoining works

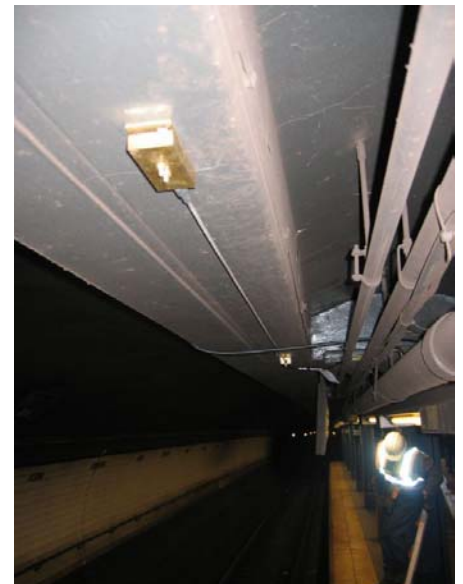
Optical Strand on a beam

- 4 Optical Strands (2 at the tunnel walls, 2 at the station beams)
- 3 Optical Strand extensometers at the mezzanine level
- 2 temperature sensors
- 1 monitoring station

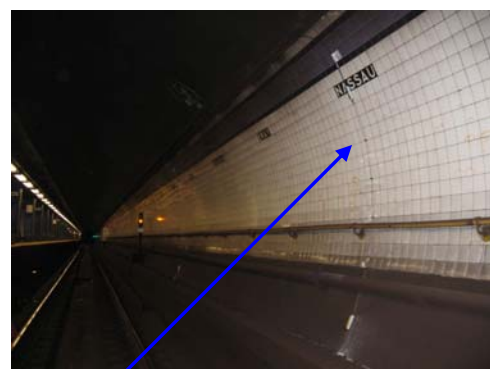
Optical Strand on the tunnel vault

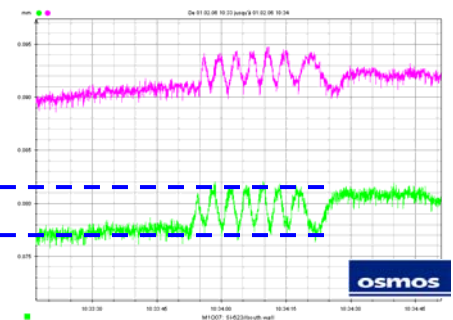
0,004 mm

Dynamic deformation after a metro train passing: The train wheels are highly visible

First results indicate that the additional load has a negligent effect on the subway structure. We were also able to capture the effect of trains on the structure in a dynamic mode.
