# Main pipe, Eisleben, Germany

## Water tunnel risk assessment monitoring

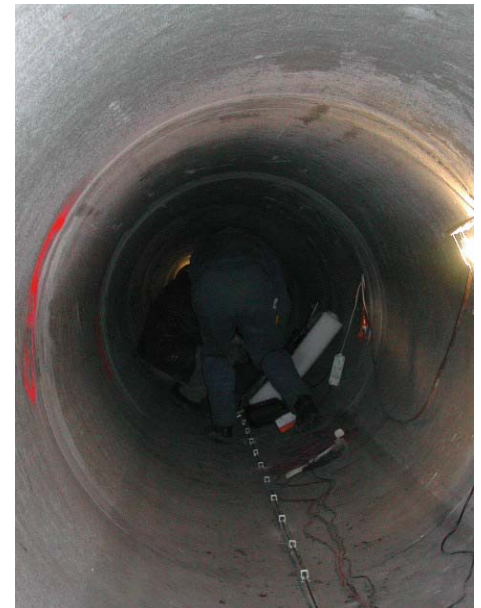
Optical Strand installation

- 1 monitoring station
- 4 Optical Strands in steel spiral sheath, in the pipe
- 2 temperature sensors

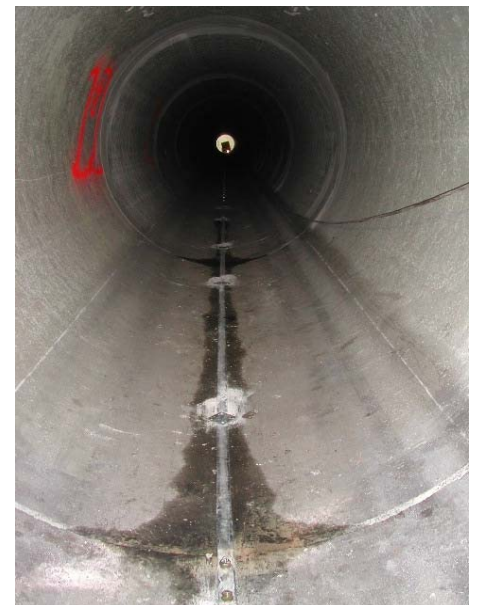
Optical Strand on the pipe

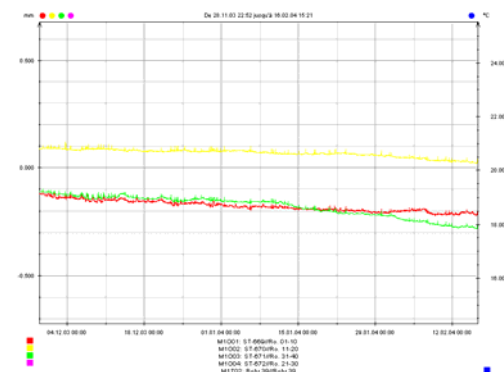
Static deformations of longitudinal Optical Strands inside the pipe

Initial results show the pipe deformation remains inside an acceptable interval, even during water charges.
